TECHNICAL REPORT NO. LWL-CR-50P71

ABRASION RESISTANT LENS CAPS

Final Report Contract No. DAAD05-68-C-0283

By
Franklin Institute Research Laboratories
Benjamin Franklin Parkway
Philadelphia, Pennsylvania

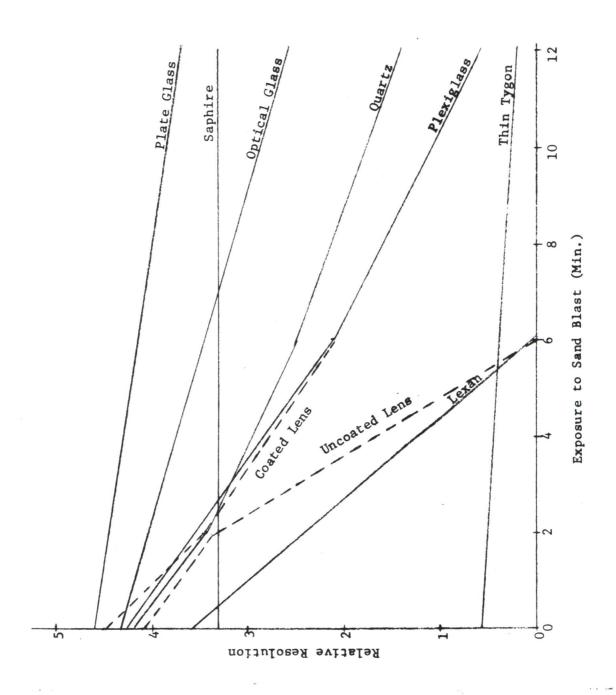
Figure 8a- Comparative Degradation of Materials & Lenses Tested.

(1) The test results summarized in Table I and Figure 8 indicate the following percentage degradation in the materials subjected to 6 minutes of dust chamber abrasion.

Material	Per Cent Degradation
Sapphire	0%
Slide Glass	11%
Optical Glass	25%
Quartz	39%
Thin Tygon	40% *
Plexiglass	49%
Polycarbonate	100%

For each of the candidate materials selected for test, resolution measurements were made prior to and after 1, 2, 6, and 12 minutes of sand and dust. Table I is a record of the raw data of the tests. Figure 8a is a graphic representation of results after smoothing (thick Tygon and Saran omitted). Figure 8b shows the same data after normalization.

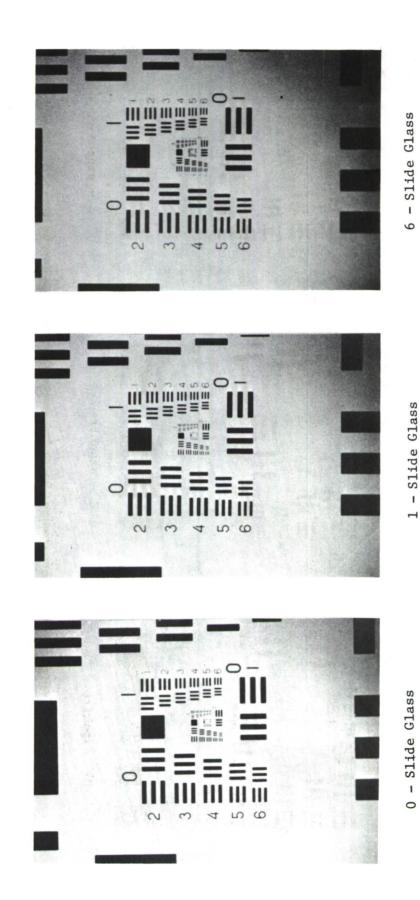
Figure 9 - Photographic Records, Image Degradation Slide Glass

Figures 9 through 15 respectively are prints of the photographic records of the data initially and after 1 and 6 minutes. The prints do not have the same resolution as the original negatives (which were read under a microscope) but they do illustrate the degradation of optical quality, not only in resolution, but also in contrast due to scatter.

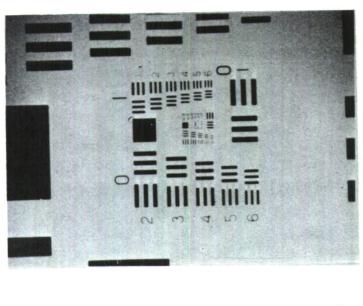
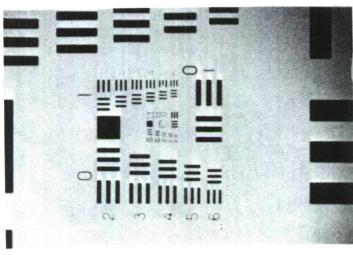
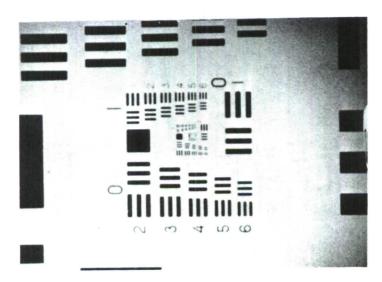
Figure 10 - Photographic Records, Image Degradation Sapphire.

- (a) Sapphire showed no apparent degradation of optical quality after 12 minutes of sandblasting. Even though the initial optical quality is below that of other materials, it is available with better quality at increased cost. (Present samples have a flatness of 10 waves/in. of dia. and parallelism of .001 in./in. of dia. at a cost of \$11.50; it is available with flatness of 2 waves/in. of dia. and parallelism of .0005 in/in. of dia. at a cost of \$20.70.)

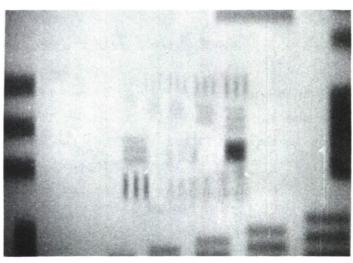
Figure 15 - Photographic Records, Image Degradation Thin Tygon.

^{*} The thin Tygon, though the test data indicates a relatively good resistance to abrasion, has such poor optical qualities it cannot be considered for use. If it could be produced with better optical qualities such as homogeneity and surface flatness, it might well be a material worth considering.

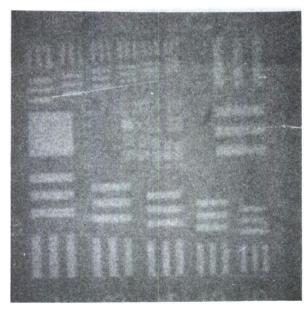
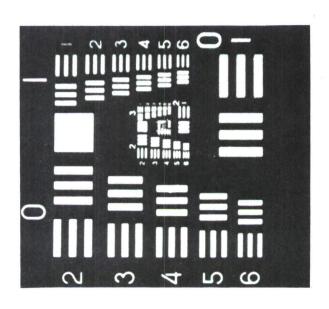
Figure 16 - Photographic Records, Image Degradation Coated Lens (Objective).

A test was conducted to compare the resolution degradation of two identical M-17 objective lenses, one with coating and one without. The resolution of the two lenses was measured initially and after 2 and 6 minutes using the technique outlined in Section 3.3.3. Table II lists the results, and Figures 16 through 19 are prints of the photographic records of the data initially and after 1 and 6 minutes. It is obvious from these that the optical coating acts as an abrasion resistant as well as an anti-reflective coating.

Table IV lists the results, and Figures 16 through 19 contain prints of the photographic results. Figure 16 shows the results of the coated lens positioned to simulate the objective lens, and Figure 17 shows the results of it positioned to simulate the eyepiece lens. Figure 18 shows the results of the uncoated lens positioned to simulate the objective lens, and Figure 19 shows the results of it positioned to simulate the eyepiece lens. The data indicates that degradation of the coated lens in the objective lens simulation degrades the resolution approximately the same as the use of a plexiglass window (compare
